**GOVERNMENT OF INDIA  
MINISTRY OF CIVIL AVIATION  
(COMMISSION OF RAILWAY SAFETY)**

**RAILWAY ACCIDENT INVESTIGATION  
REPORT**

**Derailment of 2301 Up Howrah - New Delhi Rajdhani  
Express train at km. 508/19-21 between Rafiganj and Deo  
Road stations on Gaya-Mughalsarai Grand Chord Double  
line Broad Gauge Electrified Section of Mughalsarai  
Division of Eastern Railway on 09-09-2002**

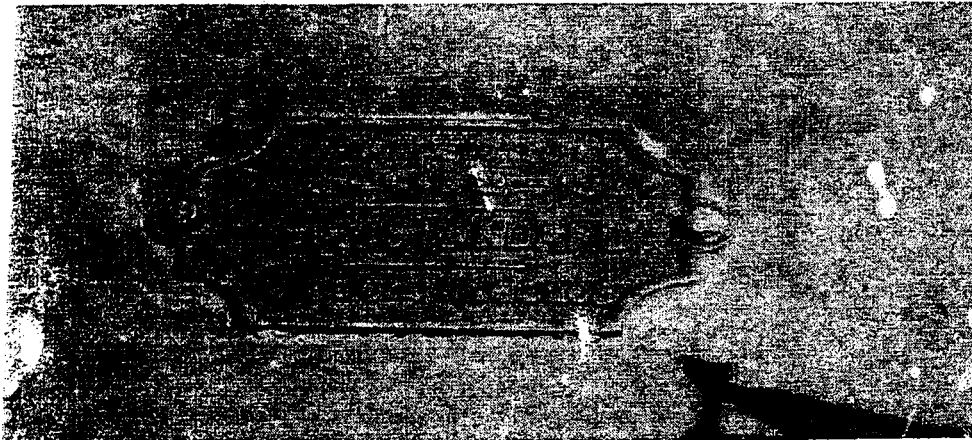
2.3 As per bridge plaque of Up line bridge girders on which Rajdhani Express met with accident, the bridge was conforming to 1916 Standard of loading and was fabricated in 1925 by M/s Burn & Co.

Bridge plaque showing standard of loading and name of the fabricator.

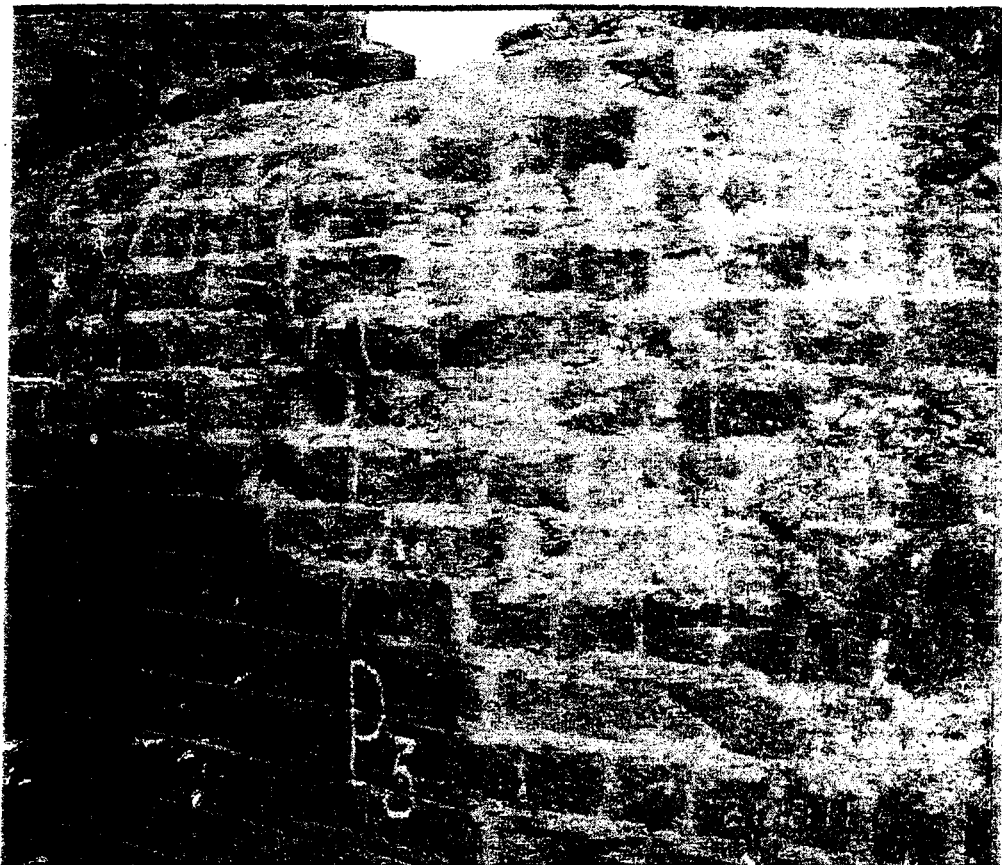
**Damaged masonry pier (P-3)**

Photographs clearly reveals that mortar is properly filled up and no weathering effect or voids are there.

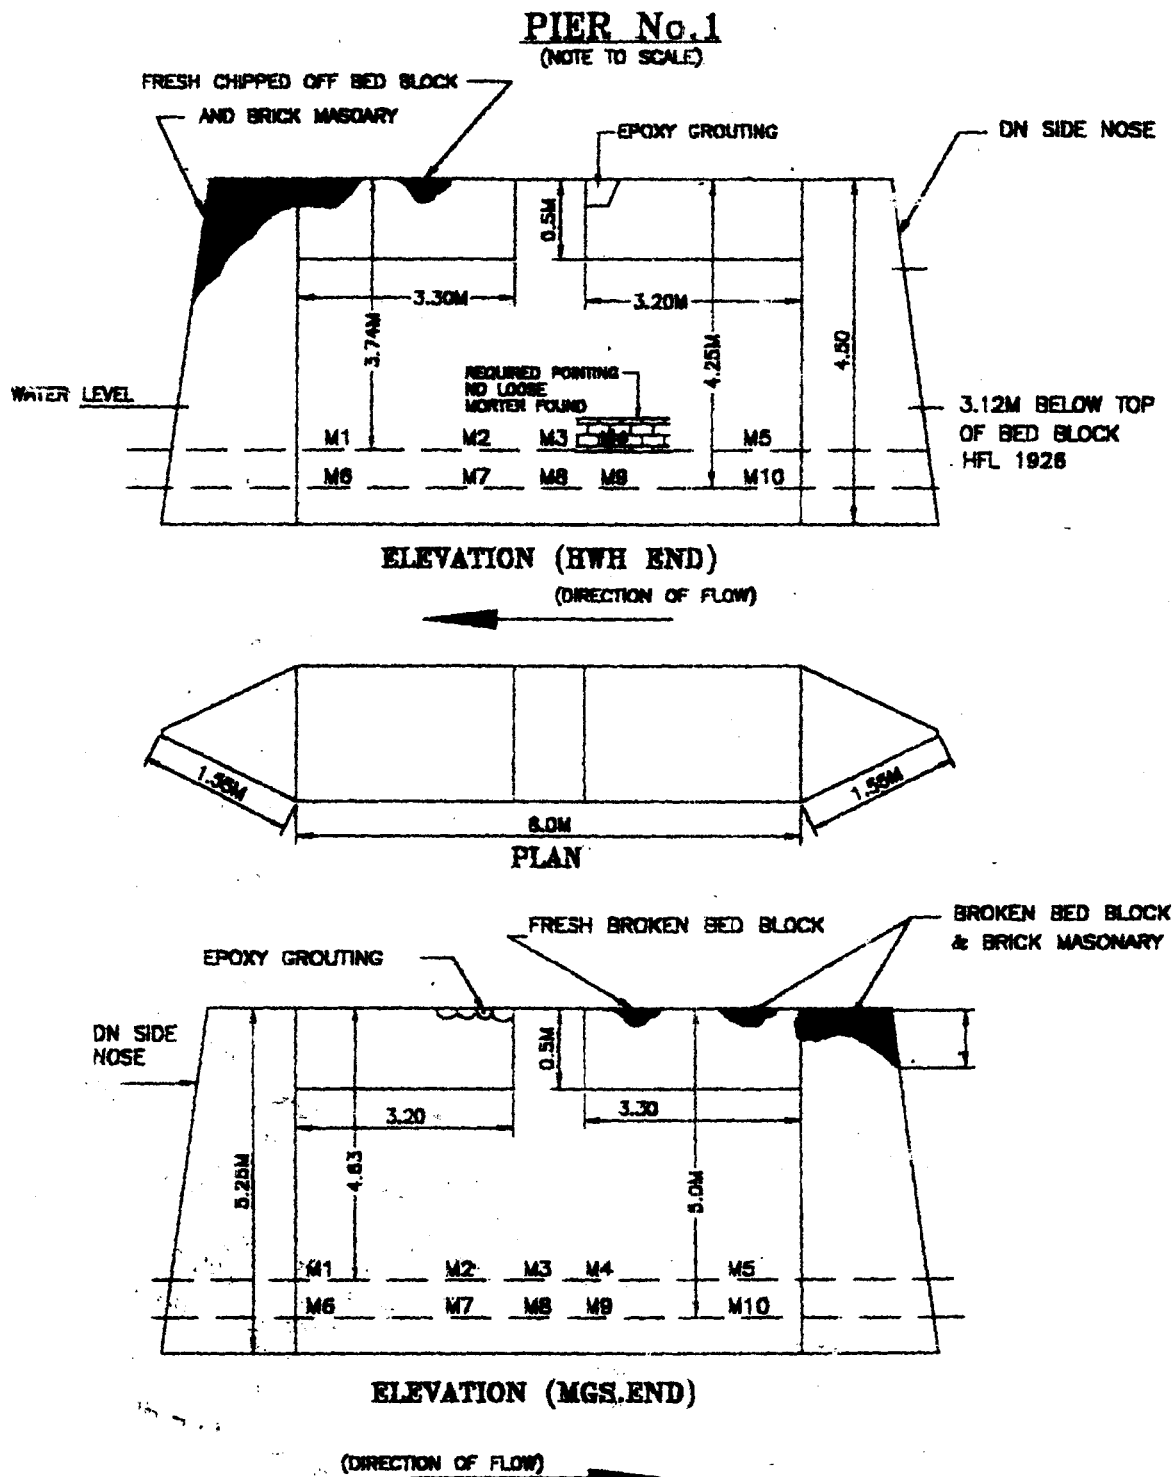
### DETAILS OF SUB-STRUCTURE OF BRIDGE No.445 MGS-GAYA SECTION

1. CONDITION OF MASONRY IS SOUND, NO WEATHERING EFFECT OBSERVED.
2. NO LOOSENESS AND LEACHING OF MORTAR FOUND.
3. CONDITION OF EPOXY GROUTING IS GOOD. NEITHER ANY LOOSENESS NOR FURTHER DEVELOPMENT OF CRACK OBSERVED.
4. NO SIGN OF SCOUR OR SETTLEMENT OF FOUNDATION WAS OBSERVED.

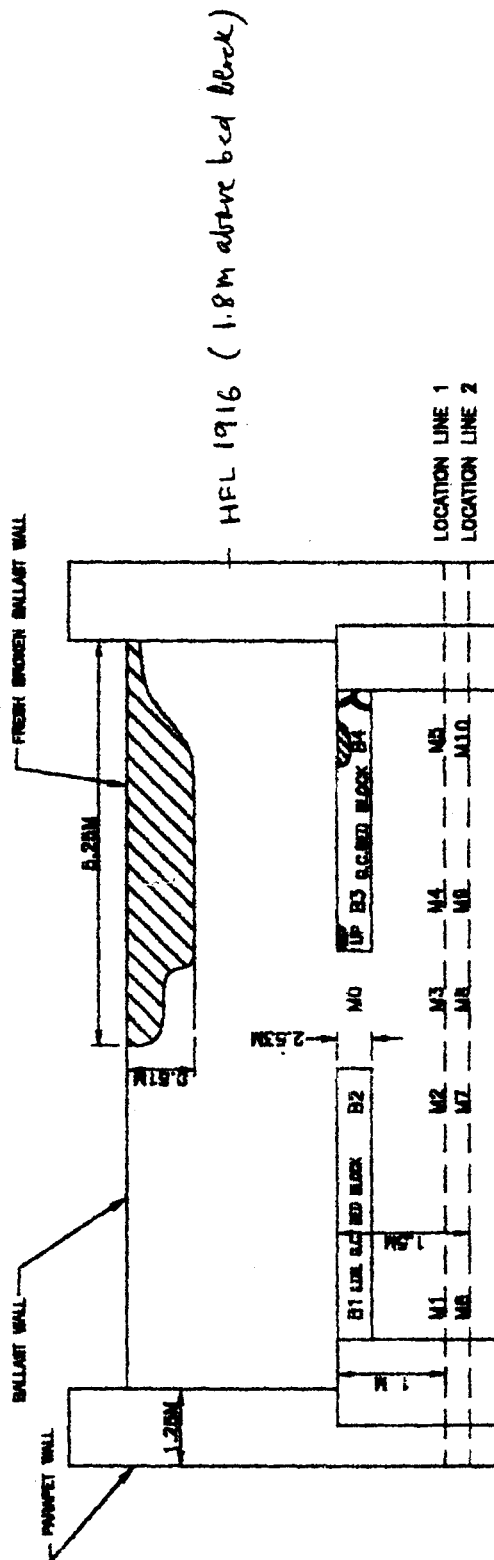
**ABUTMENT No.1**  
(NOTE TO SCALE)

STRUCTURE IS SOUND JOINTS CHECKED BY  
MIS HAVE NOT LOOSENED.

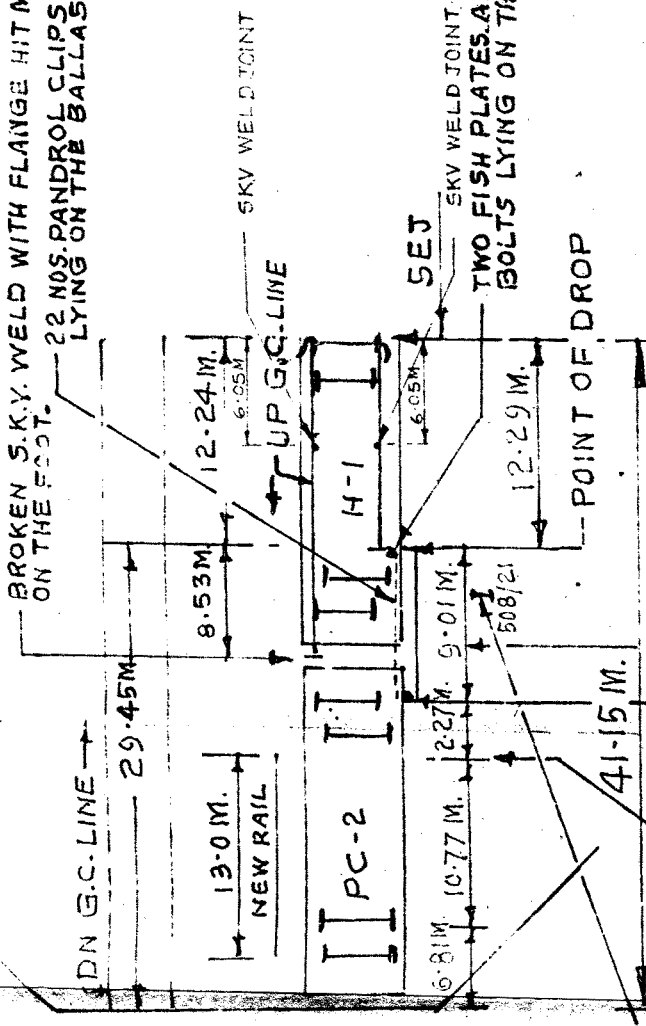
BROKEN S.K.V. WELD WITH FLANGE HIT MARK ON THE FOOT.  
22 NOS. PANDROL CLIPS LYING ON THE BALLAST

RAIL LYING OUT SIDE THE TRACK. THE INSERTS OF ONLY 4 PSC SLEEPERS FROM THE HW/H END JOINT IN INTACT POSITION AND THE INSERTS OF THE BALLANCE 10 SLEEPERS COMPLETELY DAMAGED OVER THIS PORTION.

TWO FISH PLATES AND FOUR BOLTS LYING OUT SIDE THE TRACK

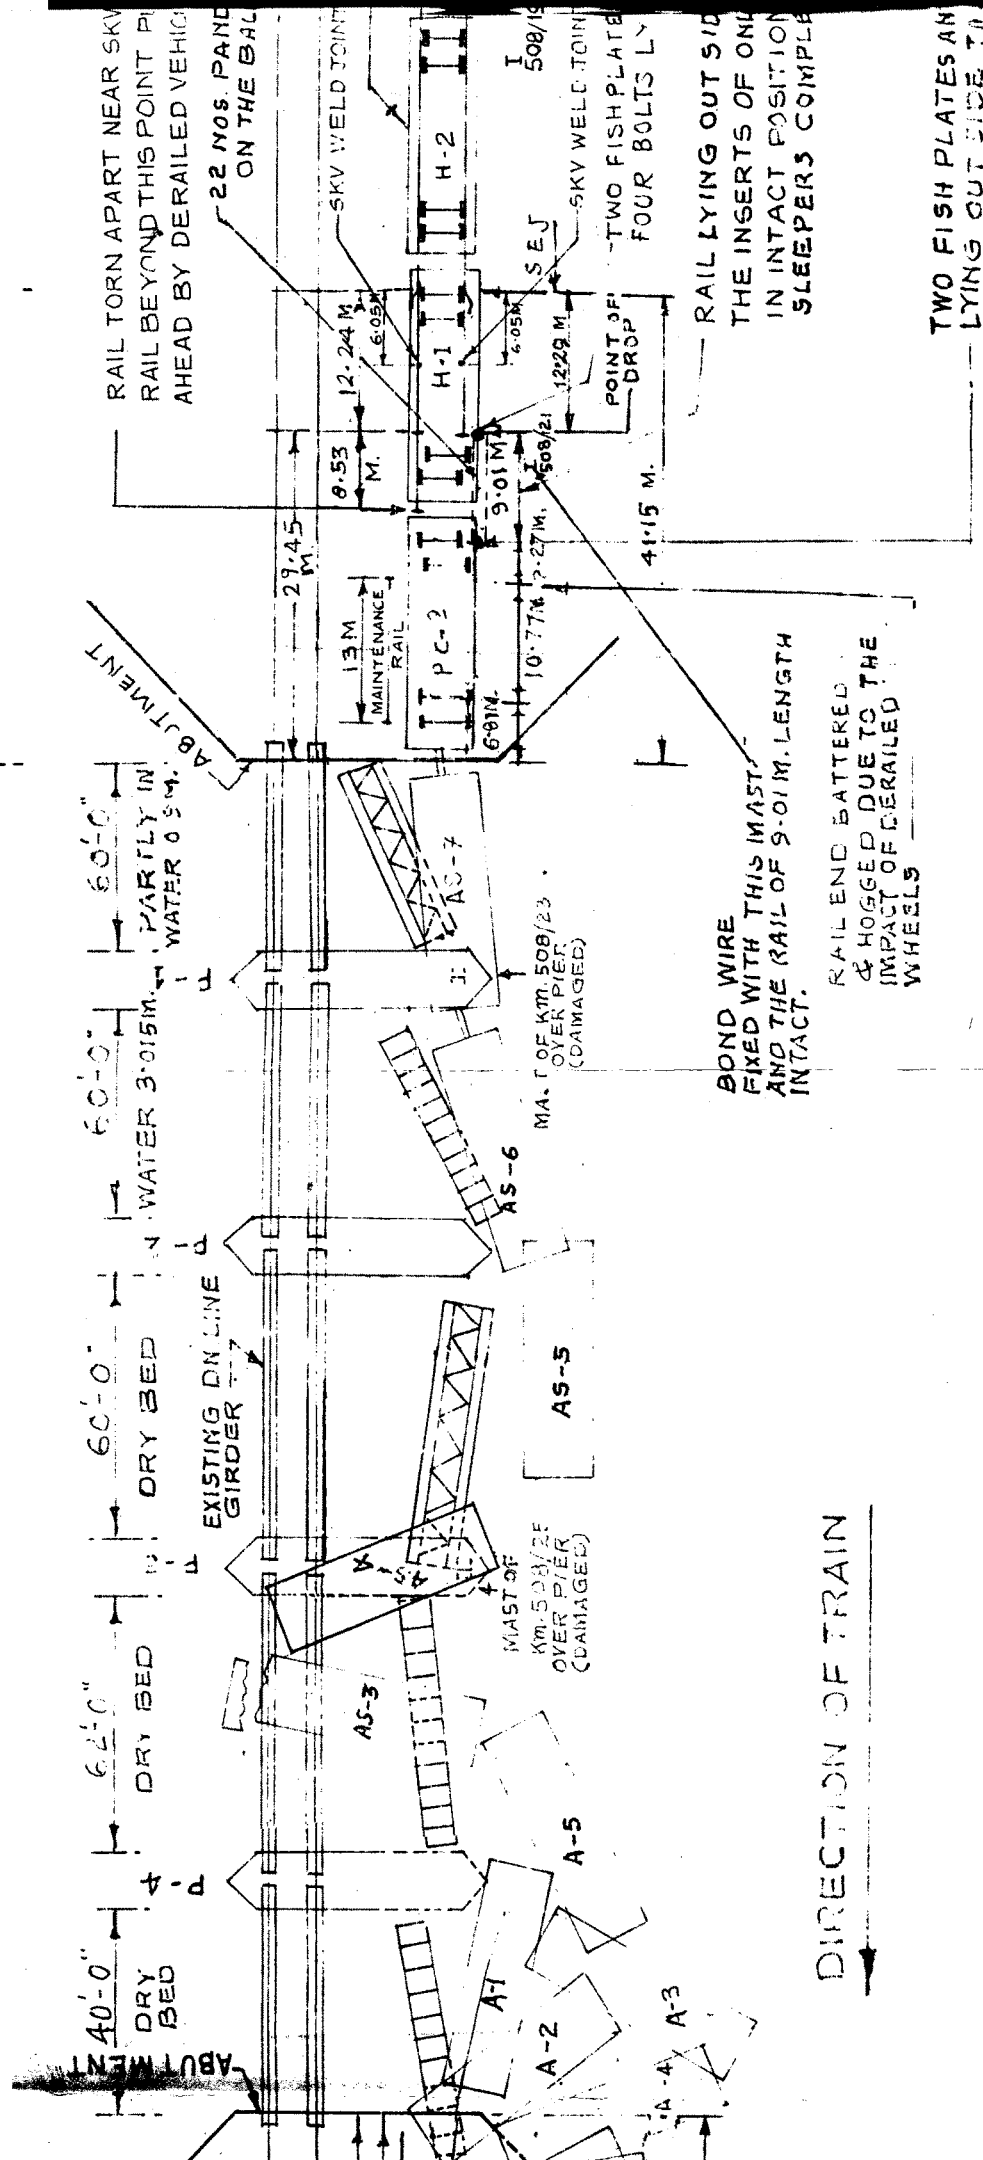
# BRIDGE NO. 445 (3x 60'-0" + 1x 60'-0" + 1x 40'-0" GIRDER) AT KM. 508/21.27

- 12.24 M - RAIL IN POSITION.
- 3.01 M - RAIL LYING OUTSIDE THE TRACK NEAR THE TOE OF THE  
PC-2 SLEEPERS WITH BOND WIRE OF MAST T. KM 508/21  
FIXED WITH IT.
- 2.27 M - RAIL PUSHED AHEAD  
RAIL NOT IN POSITION BUT LYING INSIDE WITH GAUGE.  
FACE IN DOWNWARD CONDITION AND DERAILED RAIL  
HITTING WHEELS WITH DERAILED WHEELS HITTING MARK ON RAIL
- 10.77 M -

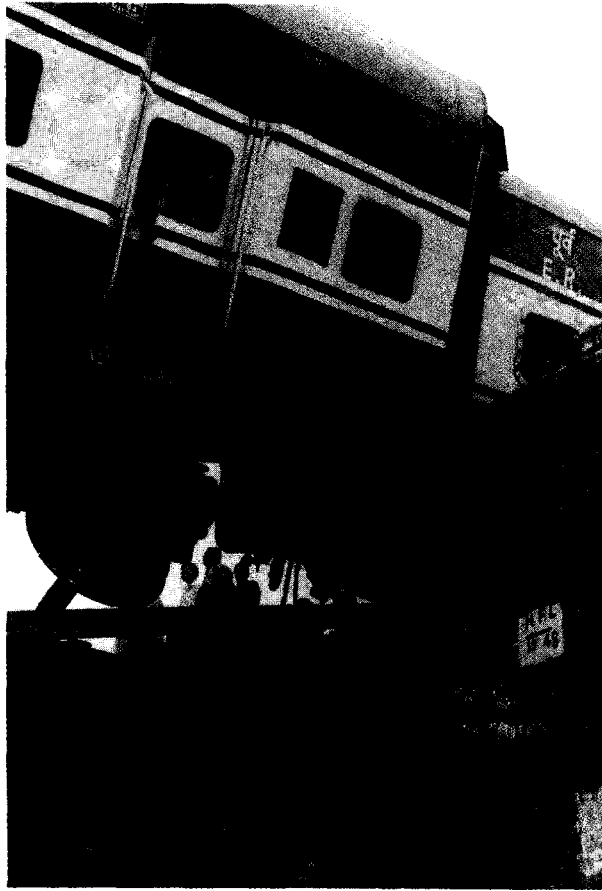
**COACHES HANGING IN SPAN NO. 1 (HOWRAH END)**

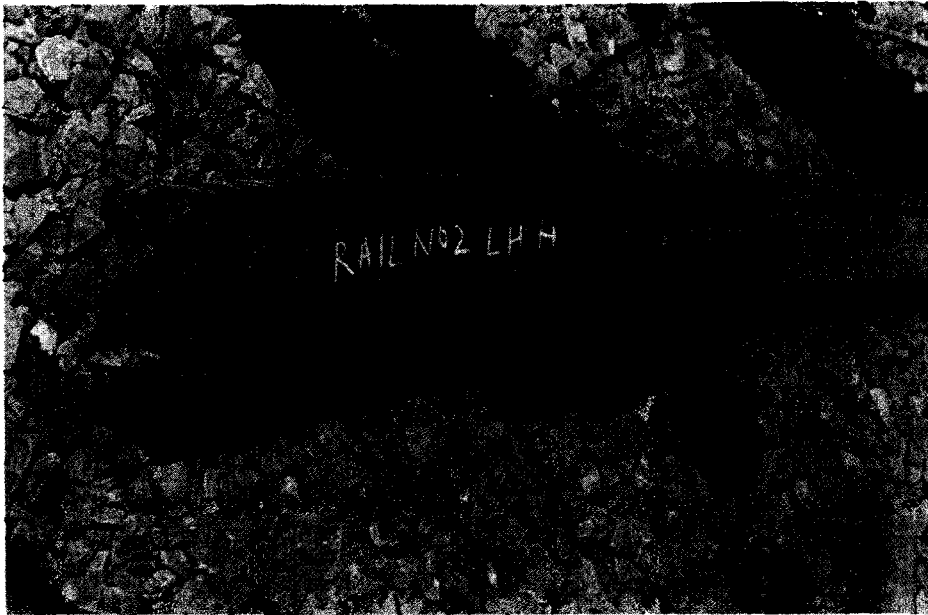
**VIEW OF BATTTERED FACE OF LANDING RAIL (GAUGE FACE)**
